## **THE DRILL HALL, PORT ROYAL, SIDMOUTH**

### **REPORT ON STRUCTURAL CONDITION**

**Vision Group for Sidmouth**

**July 2018**

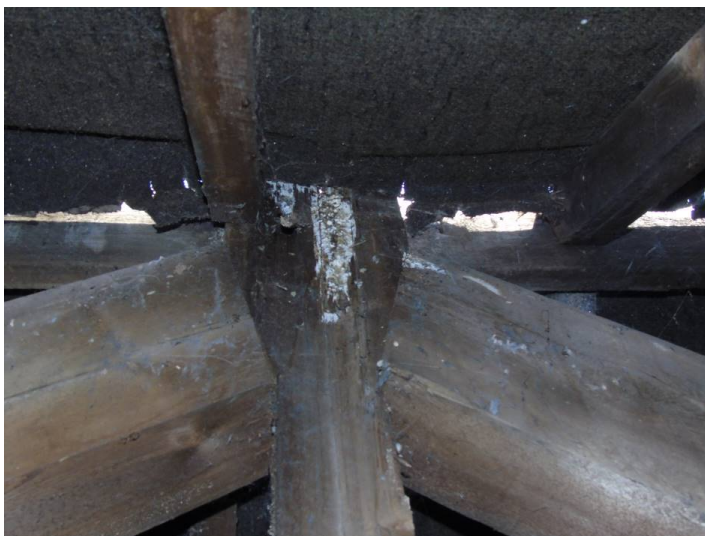
Plate 2

the bulkhead partitions on the east and west side of the first floor room. Daylight can be seen through the apex of the roof indicating that ridge tiles missing. This has been allowing rainwater to enter the roof and this appears to have caused decay in the top of the king post (see Plate 2). The southern end of the king post truss has had the top edge of the bottom chord cut just beyond its meeting with the principal rafter (see Plate 3). This leaves a short section between the tenon and notch in the bottom of the rafter to resist the horizontal thrust.

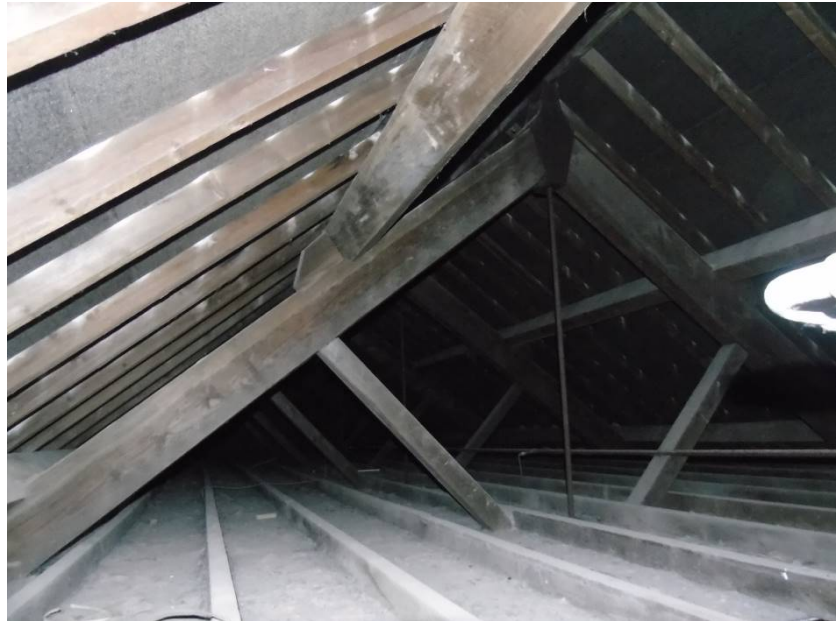
Plate 4

- 2.02 Above the hall, the common rafters are supported by three lines of purlins on each pitch which are 200 x 125 mm in size (see Plate 4). The purlins are supported by six trusses. Each truss has a principal rafter which runs down to a horizontal timber which is built into the walls and is provided with an upper collar at ceiling height (see Plate 5). Tie bars emerge from the ends of the horizontal members of the trusses while the northern two have this tie member removed and replacement ties are attached to the principal rafters near their lower end and rise to meet a vertical hanger just below ceiling level (see Plate 6). This appears to be an alteration to allow greater headroom.

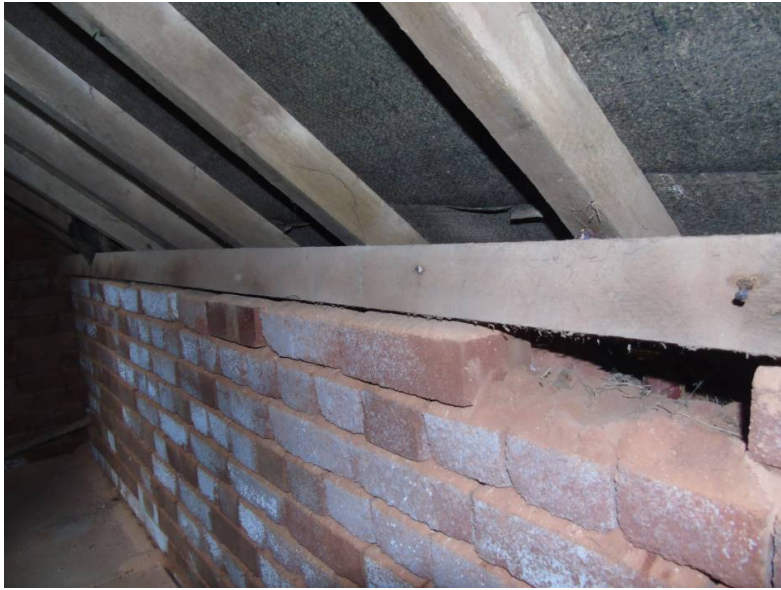
Plate 9

- 2.04 On the eastern eaves of the two storey southern part of the building, the common rafters are fixed to a substantial timber wall plate which appears to have rotated on top of the wall (see Plate 9). Some of the bricks below the wall plate are loose and can easily be removed (see Plate 10). On the western eaves, there is a valley gutter between the Drill Hall and the building to the west (see Plate 11). Although there is

- 4.01 The existing roof covering should be replaced. If a material heavier than thin Welsh slate is used, the existing timbers should be checked for their adequacy to support the additional load. The covering should also be provided with a breathable sarking fabric. The new roof should be provided with a full set of ridge tiles, preferably matching the originals and the gutters and downpipes replaced. Any decayed timbers revealed by the replacement of the roof should be replaced. The ends of the trusses concealed within the walls should be uncovered and revealed so that they can be checked for decay and the metal components checked for excessive corrosion. Any surface corrosion should be removed back to bright metal and corrosion protection coatings applied to the accessible surfaces. Consideration should be given to reinstating the original ties on the two northern trusses. Metal straps should be fixed to either side of the rafters and king post of the truss supporting the roof over the southern parts of building. Where the wall plate has been dislodged and rotated on the top of the wall, as observed at the southern end of the east wall, it should be reset and fixed to the brickwork.

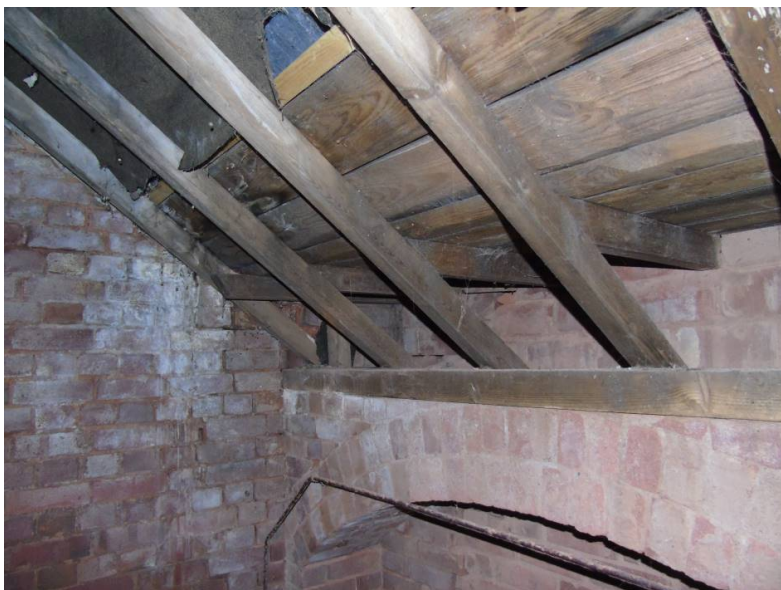
Plate 11

some water staining of the boards forming the gutter at its southern end, the timbers forming this valley appear to be generally sound.

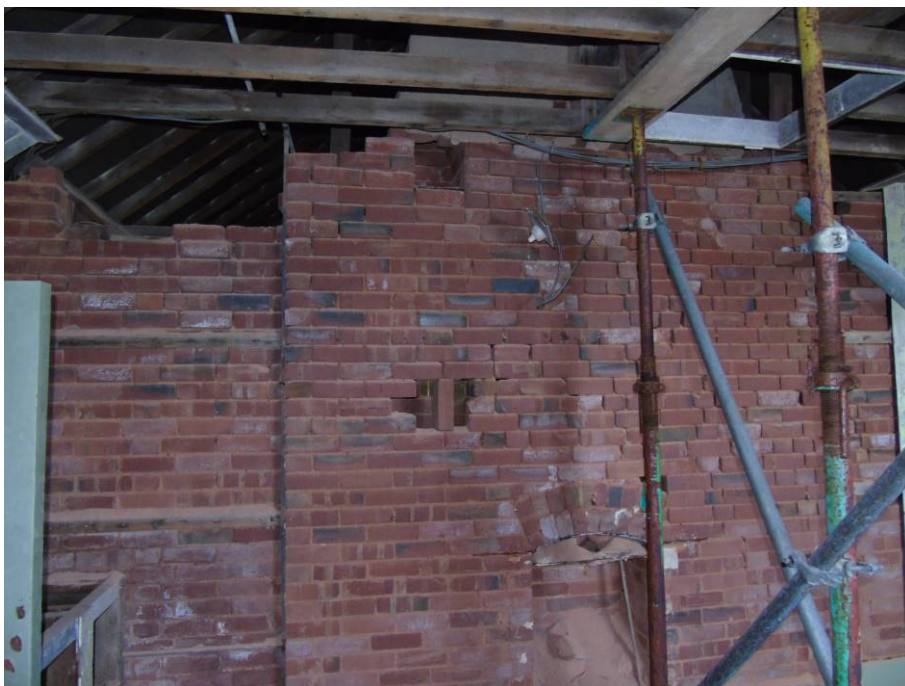
Plate 12

- 2.05 The inside face of the first floor is lined with tongue-and-groove boarding. This boarding appears to have been placed on the north wall of the first floor accommodation but much of it is now missing. This has exposed the brickwork (see Plate 12). The central area of the north wall includes a fireplace and chimney breast and it appears that the chimney may have risen through the apex of the roof. This has now been removed below the roof line and two additional common rafters have been put in place to support the roof covering where the chimney is missing. Throughout the brickwork of this internal wall on the north side of this two storey accommodation, there is extensive erosion of the mortar joints and several areas where bricks have become dislodged or are missing. There are holes on the hall/north side of this wall into the voids in the middle section which could lead into the flue (see Plate 13). This internal wall generally appears to be formed with 9-inch brickwork either side of the central chimney breast. The arch former over the fireplace in the north wall has suffered extensively from corrosion. This may have caused some disturbance to the surrounding brickwork. Behind the bulkheads on the east and west side, the top of the brick walls can be seen. These sections of wall contain alternate courses of stretcher and header indicating that it is at least 9 inches thick. At the eaves, it can be seen that there is a further thickness of brickwork beyond the inner 9-inch, possibly indicating that there is 18 inches of brickwork in total. On the south wall, headers and stretchers can also be seen on the inside face. It is therefore possible that the south wall is also formed in 13½ inch thickness of brickwork.

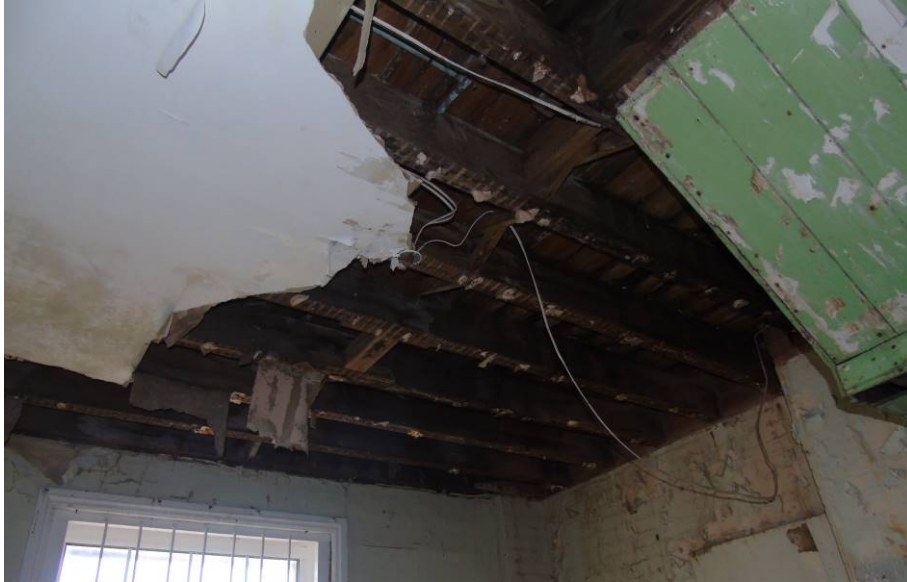
Plate 14

- 2.06 The first floor construction consists of 200 x 75 mm joists at approximately 400 mm centres spanning from east to west. These appear to be provided with support by the partitions on either side of the entrance lobby and are built into the east and west walls. Some water staining of the joints can be seen where the ceiling has fallen away, particularly adjacent to the stairs and landing (see Plate 14). However, there are no particular signs to indicate that decay has occurred beyond the surface.

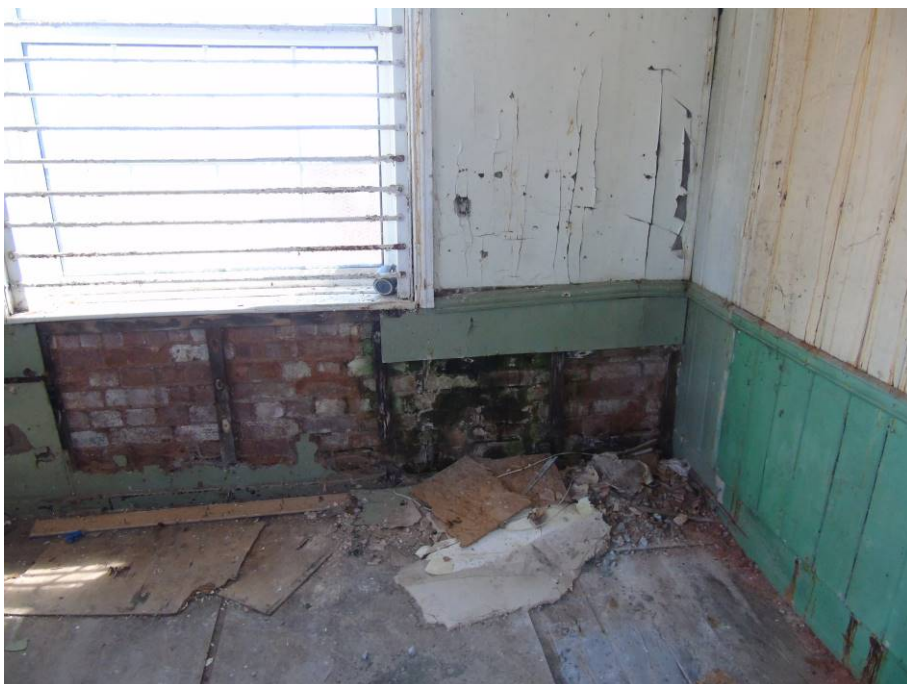
Plate 15

- 2.07 South east room. Extensive decay has occurred in the battens and boarding forming the dado on the south wall (see Plate 15). A section of ceiling has fallen away in the south west corner (see Plate 16). This reveals that the current ceiling is formed with plasterboard although it is evident that a previous plaster and lath ceiling had been attached to the underside of the first floor. Much of the wall surfaces are concealed with a lining of timber boarding, some of which is the original T & G boards. A fireplace exists in the north west corner.

- 4.03 The decayed timbers against the south wall should be replaced and, as far as possible, isolated from the possibility of becoming damp in the future.

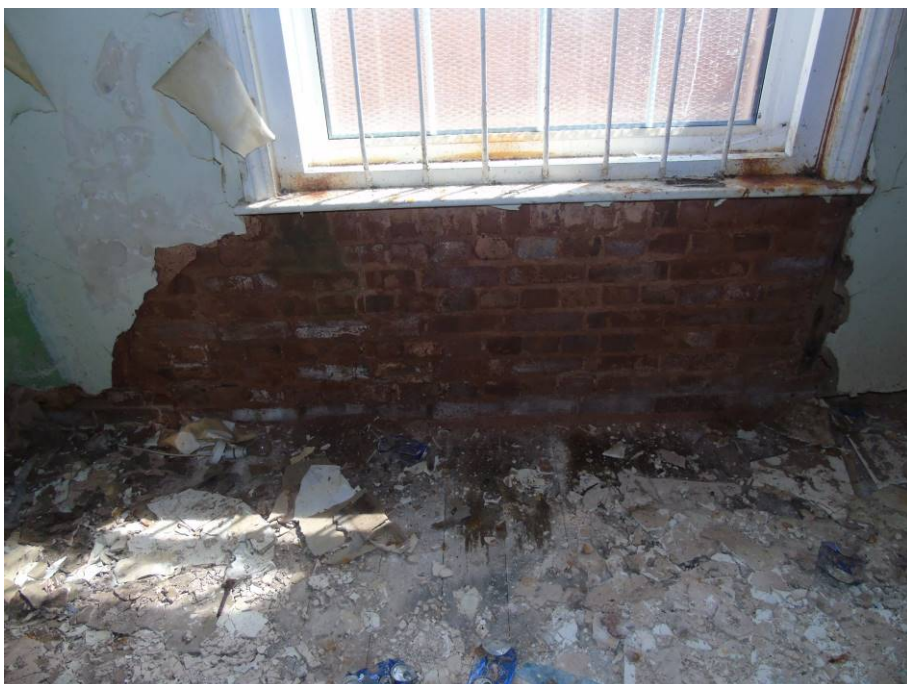
Plate 17

- 2.08 Entrance lobby. The internal walls on the east and west side of the entrance lobby are formed in 9-inch brickwork. The floor immediately inside the entrance door has a distinct slope downwards to the north. However, the skirtings appear to follow this line indicating that it had been constructed in this manner. At the southern end of the entrance lobby, just within the entrance door, is a grill which appears to cover a chute which runs down into the basement.
- 2.09 South west room. The boarding has been largely removed from the west wall to reveal the face of the brickwork which has been painted. There is also a large brickwork pier forming part of this wall. Much of the lining and plaster has come away from the bottom of the south wall to reveal the brickwork (see Plate 17). Most of the plasterboard ceiling has fallen away from the underside of the floor joists.

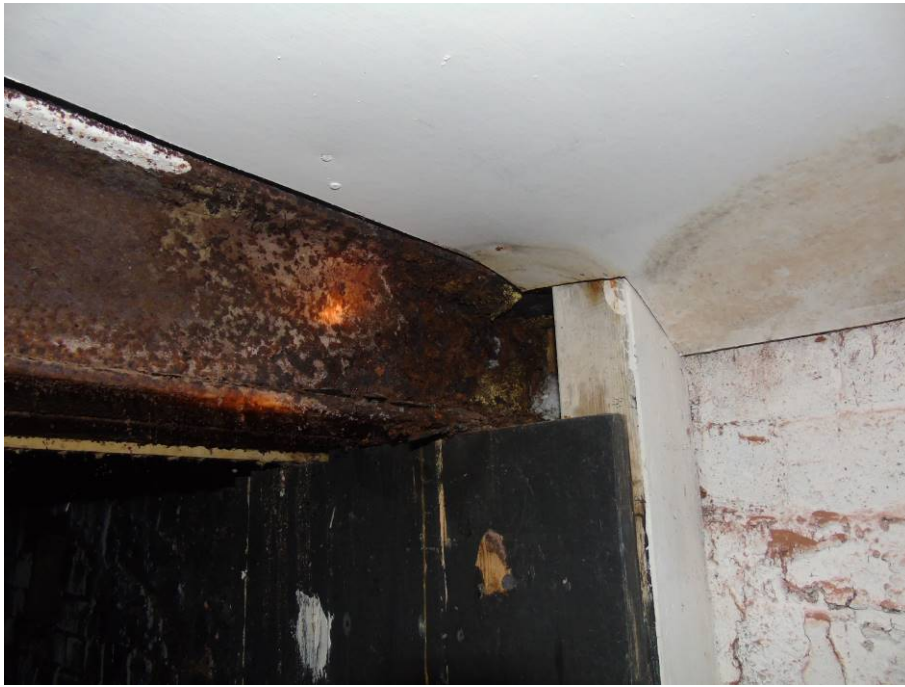
Plate 23

- 2.12 Hall floor. The floorboarding of the hall is generally intact with only a couple boards having swelled and bowed up at the southern end of the hall. Within the basement below, it can be seen that the floor joists span from east to west and are 200 x 75 mm in size at 400 mm centres. The floor joists are generally supported on a ledge in the brickwork on the west wall and built into the face of the east wall. The maximum span of the joists is 3.25 m. Some decay has occurred in the western end of the southernmost joist where it is built into the brickwork (see Plate 20). The joists are provided with intermediate support across the width of the building by two lines of steel beams which are 10-inch x 5 inch I-section and span up to 6 m between supports. At the southern end of the building, the two steel beams are set closer together and provide direct support for the 9-inch brick walls above. Both of these beams have suffered from extensive corrosion, particularly towards their southern end (see Plate 21). The southern joist spanning eastward from the eastern beam has suffered extensively from decay where it sits on the top of a brickwork ledge. Two steel beams can be seen which span over this eastern section of the basement and probably coincide with the internal wall dividing the hall from the two-storey part. Extensive corrosion has occurred at the eastern end of these beams (see Plate 22). Corrosion has also occurred where the steel floor beams are built into the north wall (see Plate 23).

- 3.04 The floor construction is generally sound with adequate sized floor joists and steel beams. However, the corroded sections of steel beam at the southern end of the building have reached a point where they are beyond repair and will therefore need to be replaced. This will require the temporary support of the floor joists and the internal brickwork walls on either side of the entrance lobby while the beams are replaced. Other sections where corrosion has occurred, such as the northern bearings of the beams and the eastern bearing of the beam supporting the wall between the two storey section and the hall, will need to have the existing corrosion cleared from the surface and removed so that the remaining section can be checked for its adequacy and protected from further corrosion.

- 4.02 The two heavily-corroded beams supporting the internal partitions on either side of the entrance lobby should be removed and replaced. The new beams should be isolated from damp conditions as far as possible and provided with corrosion protection suitable for a marine environment. Alternatively, the replacement beams could be formed in stainless steel. The corroded ends of beams built into the north and east walls should be uncovered and the corroded material removed so that an inspection of the remaining section can be made and checked for their adequacy to support the current loading. The remainder of surfaces of the beam supporting the floor should also be cleaned back to clean metal and recoated with a suitable corrosion protection system

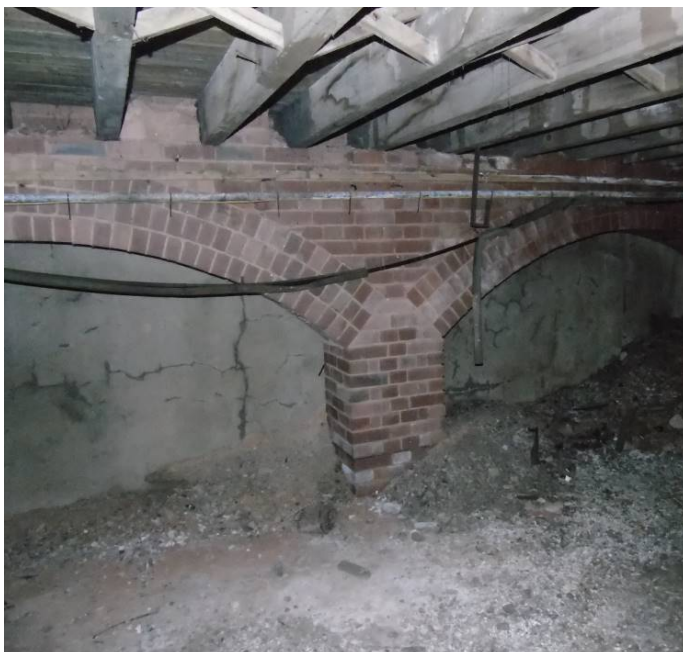
Plate 24

- 2.13 Basement. In the south wall of the basement, there are openings which have been filled with blockwork. The west wall is formed with a series of brick arches which are sat on in 18 x 23-inch piers (see Plate 24). The steel beams are supported by two 18-inch square brick piers on each length which are capped with granite padstones (see Plate 25). Adjacent to the eastern of the steel beams, a line of brickwork wall has been formed. To the west of this brickwork wall, the floor is gravel. To the east, a concrete floor has been laid. To the east of this wall, a concrete slab has been laid over the gravel. Arches can also be seen in the east wall but these have all been infilled with brickwork so that it is flush with the inner face of the piers and arches. An area at the southern end of the eastern part of the basement could not be accessed as it appears to be boarded off. There are further brickwork walls at the northern end of the basement. It is not clear whether these are original or have been added. The stairs giving access to the basement have walls formed with a timber frame on the north, west and east sides. This includes more substantial timber posts. Decay has occurred at the bottom of these posts (see Plate 26).

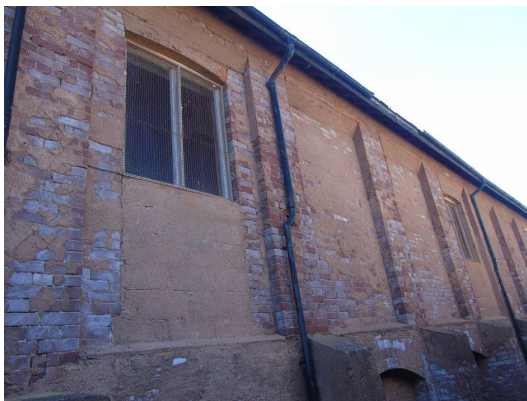
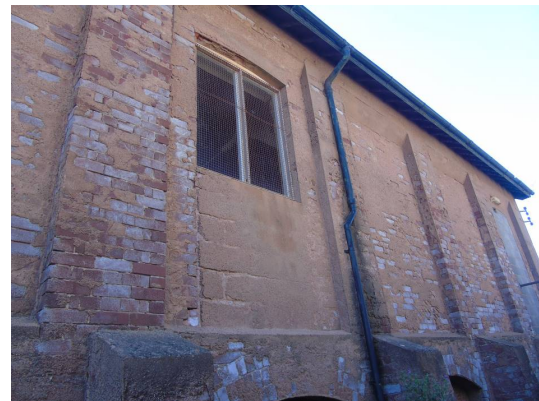
- 2.14 East elevation. Much of the brickwork is exposed on the east elevation although it can be seen that it had been rendered which has eroded from the surface. It can also be seen that below the two windows serving the hall, the lower section has been infilled with blockwork (see Plates 27 & 28). It is also noted that the section of wall below the window serving the south east room has also been infilled with blockwork. The blockwork filling the northern door opening is more recent. Throughout the length of the wall, there are projecting buttresses. These roughly coincide with the piers between the arches at the basement level and piers at the upper level but are slightly offset. There are no specific signs of cracking or movement in the wall surface. At the northern end of the east wall, there is a large blocked opening which would have led onto a steel staircase which would probably have been the fire escape. The fire escape has suffered extensively from corrosion and several of the treads have collapsed (see Plate 29).

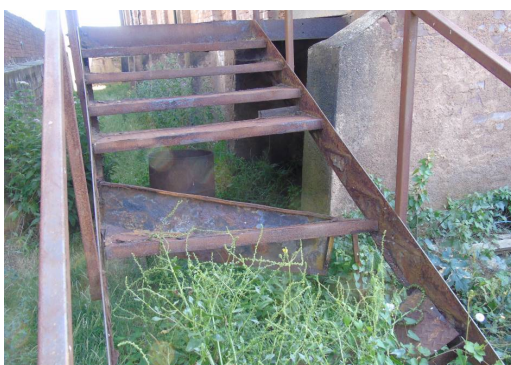
Plate 29

- 3.07 The horizontal cracking which can be seen in line with the heads of the windows in the toilet block are likely to be caused by the corrosion of the steel lintels. These lintels will therefore require replacement.
- 3.08 The external fire escape at the northern end of the east wall has suffered corrosion to the point where it requires replacement. The stairs leading from the north of the hall to the basement will require extensive repair work and replacement of decayed sections of timber. However, it may be possible to retain the bulk of the timbers forming this stair and its enclosure.

- 4.10 The existing fire escape attached to the northern end of the east elevation should be replaced. The replacement should be constructed with materials which will be resistance to damage from the marine environment.

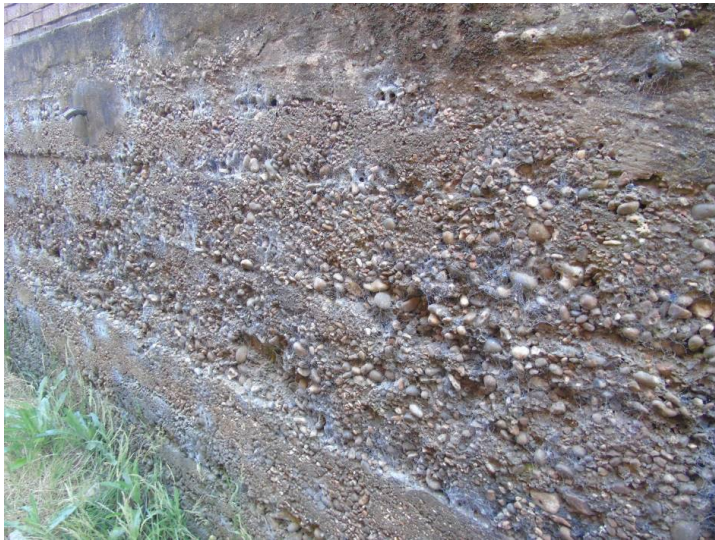
Plate 30

- 2.15 To the east of the wall is an open area and approximately 3 m to the east is a retaining wall which appears to be formed with mass concrete which has rounded gravel as the aggregate (see Plate 30). This wall appears to be upright.

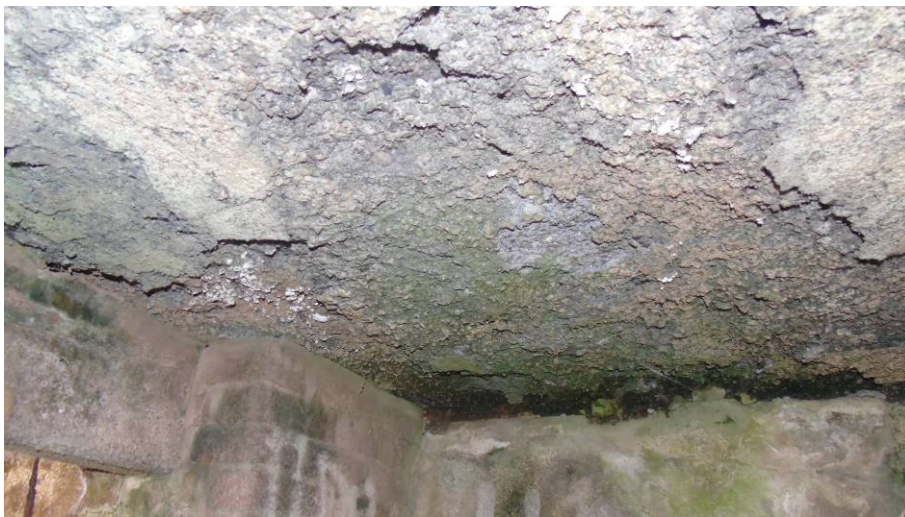
Plate 31

- 2.16 South elevation. A reinforced concrete deck bridges between the retaining wall to the south of the building and the entrance door. Extensive erosion has occurred on the underside of this deck with concrete having spalled away from the underside (see Plate 31). Concrete has peeled away from the edge beam on the west side of the deck to reveal corroding reinforcement (see Plate 32). Corroded steel and missing concrete can also be seen on the underside of the edge beam on the east side of the deck (see Plate 33). The brick piers and walling either side of the bridging deck are formed in much later brickwork.

- 3.06 It is evident that the salt-laden water has also caused corrosion in the steel reinforcement for some of the reinforced concrete elements of the building including

the bridge deck in front of the main entrance and the beams supporting the toilet block. The extent of the corrosion in the beams below the toilet block could not be identified as they were still concealed within the concrete. However, it is likely that this reinforcement would need to be exposed and the corroded metal removed before replacing the cracked concrete. With regard to the bridge deck, the corrosion of the edge beams is such that the beams as a whole will need to be replaced. As the condition of the reinforcement within the deck itself is unknown, it may be prudent to assume that the deck as a whole will require replacement. In view of its location, the replacement should be formed using stainless steel reinforcement.

- 4.04 The deck and edge beams forming the bridge to the entrance door should be replaced. If the replacement is formed in reinforced concrete, the reinforcement should be stainless steel. The current brick piers supporting the bridge deck can be retained.

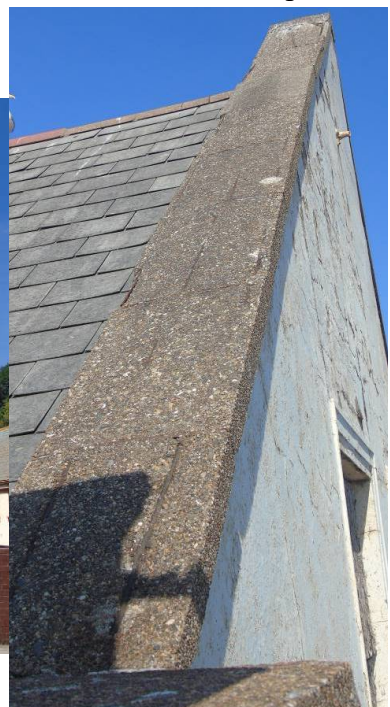
Plate 35

- 2.17 The external face of the south wall is coated with a cement-based render which has been painted. Much the paint is peeling away and there are several cracks in the surface of the render. Numerous cracks can be seen throughout the height of the wall and the top of the gable peak appears to be leaning southwards. In particular, there is a line of horizontal cracking just above the level of the sills of the first floor windows (see Plate 34). Some erosion of the capping stones can also be seen at the top of the south elevation. Reinforcing rods have become exposed on the outer surface (see Plate 35).

- 4.08 The render should be removed from the south elevation and investigations carried out to determine the cause of the horizontal lines of cracking. The investigation should include a search for steel components built into the wall which could be suffering from corrosion. The top section of the gable peak should be reformed in the original upright position. The remaining render on the east, west and north elevations should also be removed back to bare brickwork. Where the mortar joints have been eroded, they should be raked out and refilled with new mortar. The replacement render should be a lime-based material and breathable. Any decorative finishes should also be breathable.

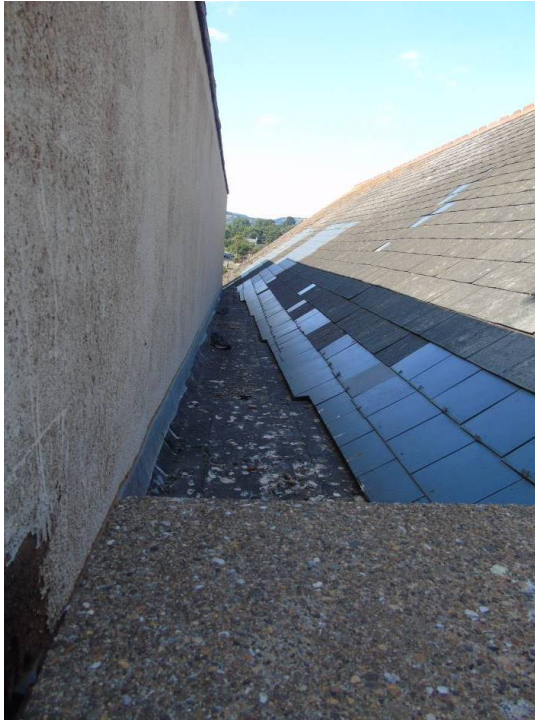
Plate 42

- 2.20 West wall. The southern part of the wall is obscured by the adjoining building with a valley gutter between the two buildings (see Plate 42). A small gap exists at the northern end which is largely inaccessible. Debris fills the gap between the Drill Hall and the retaining wall forming the area to the west (see Plate 43). However, it can be seen from this side, that the infill panels of brickwork are formed with just 4 inches thickness. The gutter is mostly missing from the eaves and there appears to be some decay of the rafter ends towards the southern end of this area. (see Plate 44)

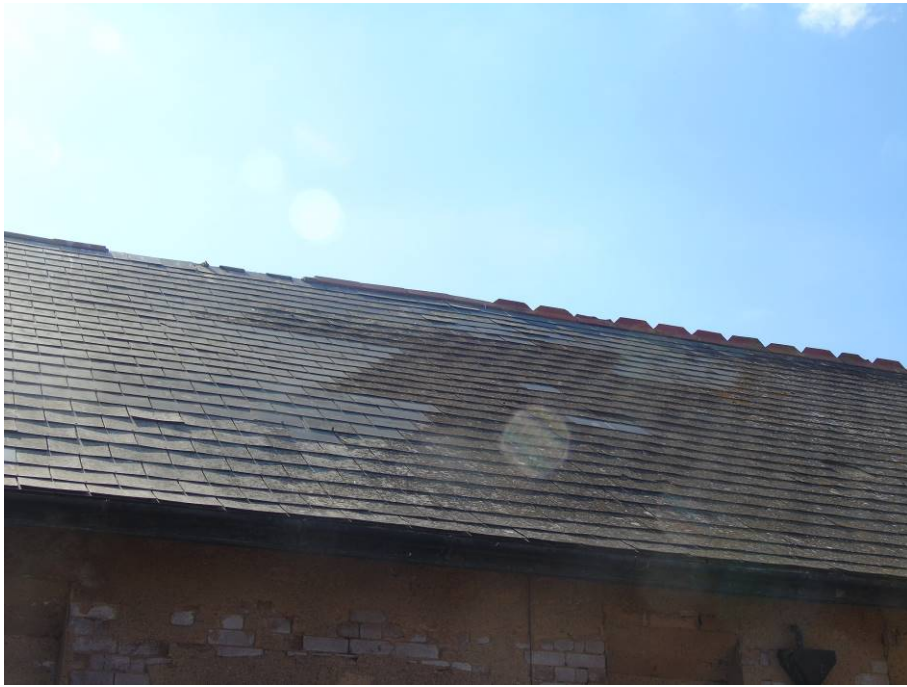
Plate 45

- 2.21 The current roof covering appears to be asbestos cement slates which have been patched in some areas with later slates. Several of the older slates are also missing and are curling (see Plate 45). There are several ridge tiles missing towards the southern end of the ridge (see Plate 46). Sections of gutter are also missing from the east eaves.

- 3.05 The weatherproofing of this building will be important for its long-term future. Most of the asbestos cement slates are coming to the end of their useful life and the missing ridge tiles will need to be replaced. Furthermore, the cappings on the parapet at the top of the south wall will also need to be replaced. As the wall construction generally appears to be solid brickwork, it will also be important to provide an adequate barrier to rain and spray on the external surfaces of the walls. A cement-based render should be avoided in this situation as it will tend to hold the moisture within the building. A breathable coating system should be adopted and consideration could also be given to improving the thermal performance of the external walls at the same time. There are now many solutions to this situation which could be considered.
