Our Ref:
2469-L001-IJ-021211.doc

02 December 2011

Sidmouth Drill Hall: Pre-Demolition Inspection

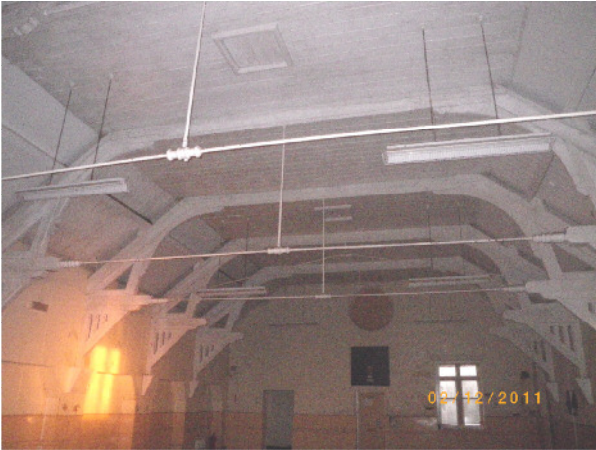
1

The main part of the building is an open assembly hall at ground floor level, which has external brick walls supporting a series of timber roof trusses (photos 1-3). The trusses are slightly unusual in that they have hammer-beam style ends and raised collar ties, but also have a horizontal steel tie bar, supported at midspan by a central vertical steel hanger rod. There is a timber boarded ceiling at collar beam level, with hatches to gain access to the triangular roof space above the ceiling. (These were inaccessible at the time of the inspection as scaffolding or a tower would be necessary.) The main pitched roof is slated.

In particular, it is unlikely that it will be practicable to lift off the main timber roof trusses in one piece, and they will need to be cut into manageable sections, using temporary scaffolding as propping. The ends of the trusses are carried directly on the external walls, and will be providing lateral support to these. Thus, removal of the trusses will potentially destabilise the side walls and the temporary propping system will need to take account of this until the walls can be safely brought down.

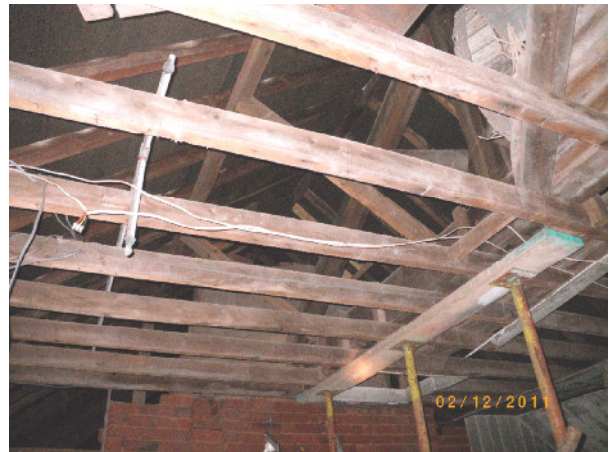
4

have been installed at the centre (photo 4), with further propping at ground floor in the entrance area directly below. The propping at first floor aligns with the purlin struts and, although there were no particular signs of current movement or distress, it is possible that a central partition which originally supported the ceiling joists and struts, has at some time been removed and the props were put in as a result of the roof starting to sag.

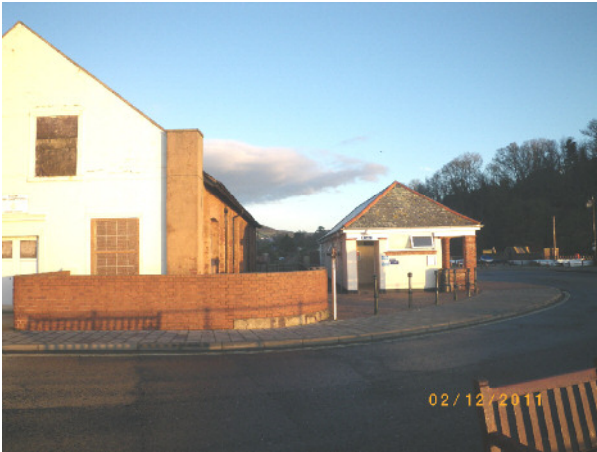
7

The building has a basement area under the entire main footprint, but the ground on the front, east side, and rear of the building is at the same level as the basement floor – i.e. the basement walls on these three sides are not retaining walls. The drawings of the Sailing Club do not indicate a basement immediately adjacent to the Drill Hall, therefore the Drill Hall basement wall on this side must be assumed to be a retaining wall. There are external retaining walls along the front of the building at the back of pavement, and along the east side adjacent to the public toilets (photo 7). These retaining walls are structurally independent of the building.

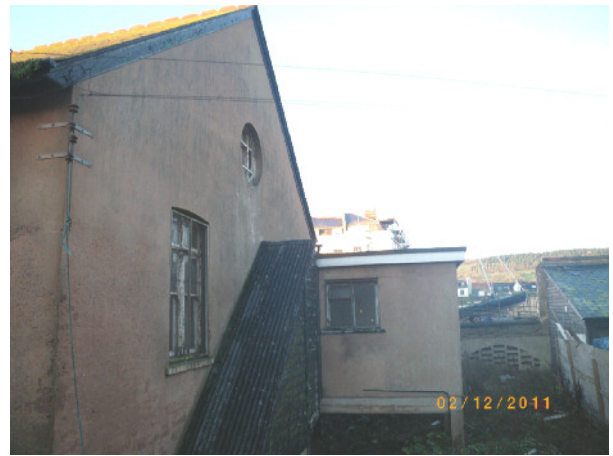
10

At the rear of the Hall, there is a small single-storey extension with a flat roof (photo 10), which houses the ladies and gents toilets.

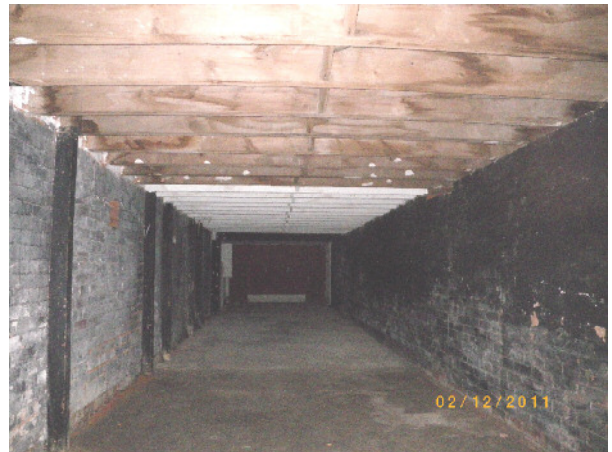
18

The ground floor of the main Hall, which is directly above the basement, has timber floorboards on timber joists. The joists span transversely between the external walls and an internal brick spine wall (photo 18), and a steel beam running from front to rear which is supported on concrete padstones on top of brick columns (photo 19). The basement wall next to the Sailing Club is formed of a series of elliptical arches between buttresses (photo 20).

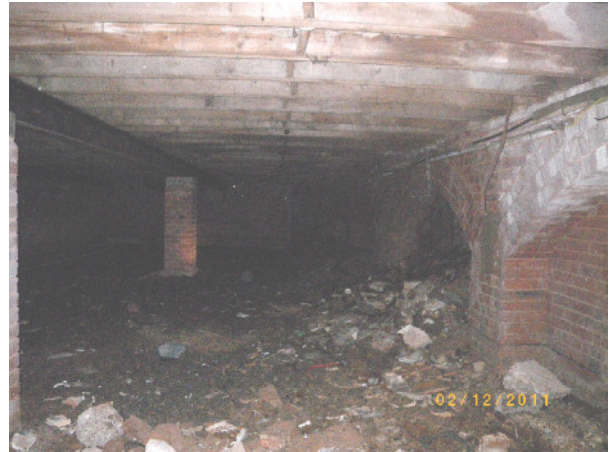
20

It is not possible to be certain of the structural action of the basement wall which forms the retaining wall alongside the Sailing Club. Whilst it is possible that the basement wall is structurally adequate as an independent retaining wall in its own right, it may - either intentionally or over time - be that the existing timber floor in the Hall is providing propping restraint at ground floor level. The vertical loads from the masonry superstructure and the roof above will certainly be providing additional assistance. In order to ensure stability of the retaining wall, it will therefore be prudent for infill material to be placed against the basement wall before the ground floor is removed in its entirety. The basement void immediately adjacent to the Sailing Club should therefore be progressively infilled to at least half its height, in advance of removal of the adjoining section of ground floor.
