## **THE DRILL HALL, PORT ROYAL, SIDMOUTH**

### **REPORT ON STRUCTURAL CONDITION**

**Vision Group for Sidmouth**

**July 2018**

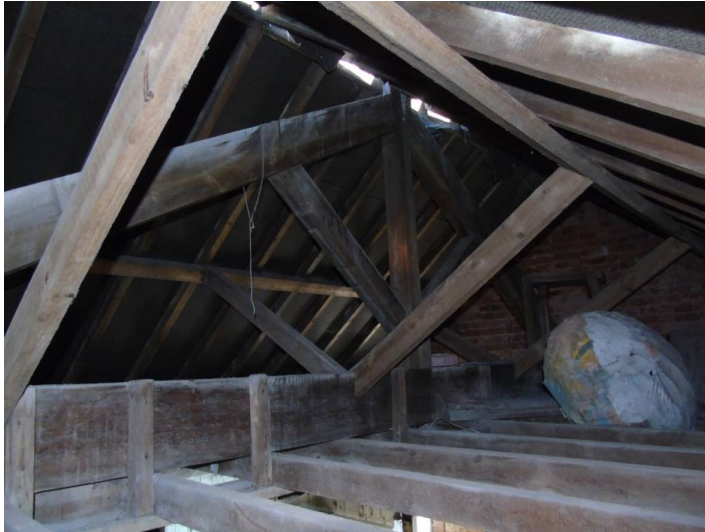
Plate 1

the bulkhead partitions on the east and west side of the first floor room. Daylight can be seen through the apex of the roof indicating that ridge tiles missing. This has been allowing rainwater to enter the roof and this appears to have caused decay in the top of the king post (see Plate 2). The southern end of the king post truss has had the top edge of the bottom chord cut just beyond its meeting with the principal rafter (see Plate 3). This leaves a short section between the tenon and notch in the bottom of the rafter to resist the horizontal thrust.

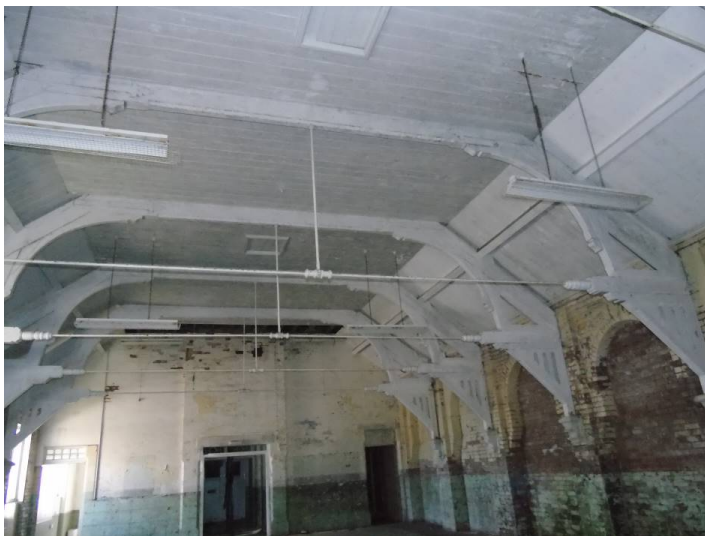
Plate 5

- 2.02 Above the hall, the common rafters are supported by three lines of purlins on each pitch which are 200 x 125 mm in size (see Plate 4). The purlins are supported by six trusses. Each truss has a principal rafter which runs down to a horizontal timber which is built into the walls and is provided with an upper collar at ceiling height (see Plate 5). Tie bars emerge from the ends of the horizontal members of the trusses while the northern two have this tie member removed and replacement ties are attached to the principal rafters near their lower end and rise to meet a vertical hanger just below ceiling level (see Plate 6). This appears to be an alteration to allow greater headroom.

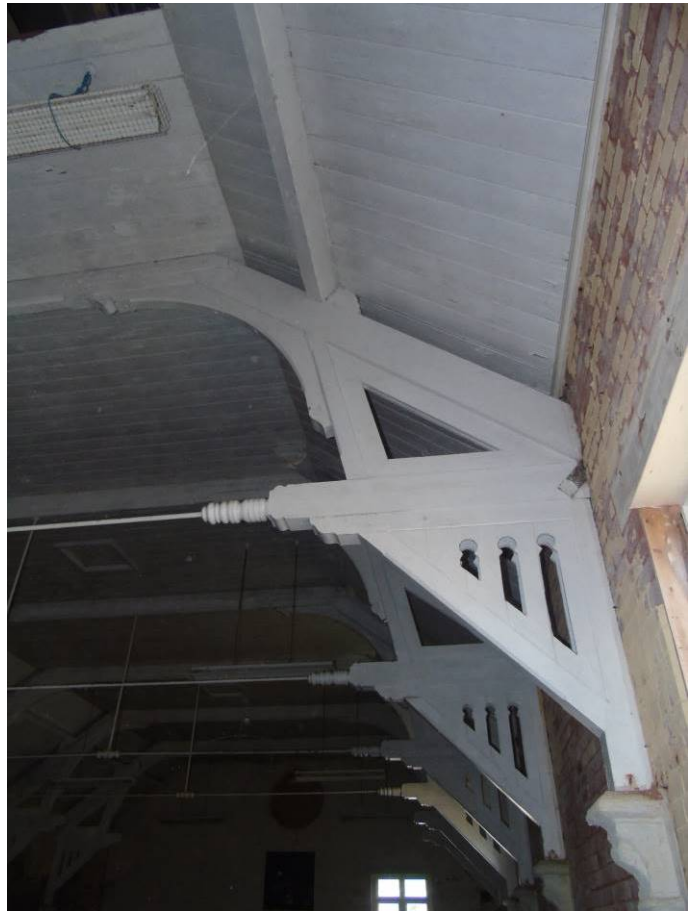
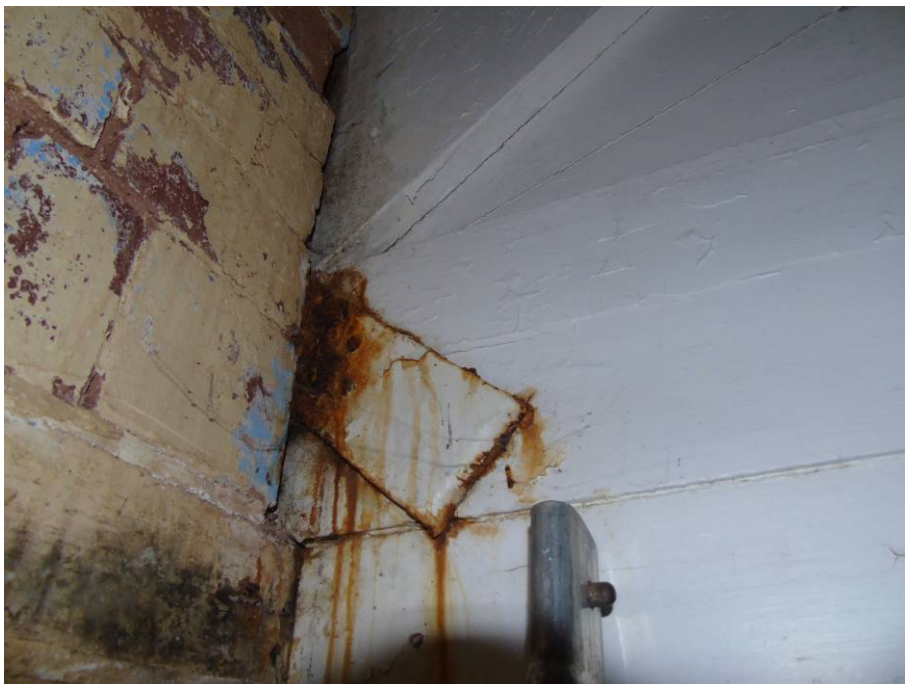
Plate 8

- 2.03 Vertical posts and raking struts rise up from corbels at approximately mid height of the wall to meet the underside of the horizontal timber and there is a further raking strut from the horizontal timber to the underside of the principal rafter with arch braces attached to the upper collar, rafter and raking strut (see Plate 7). The ends of the main trusses are built into the wall construction. Several of these bearings were inspected to check for decay in the visible part of the truss and to a certain extent, into the depth of wall where a gap existed. No decay was found in the trusses that were examined. Some corrosion of the metal strap which is fixed to the side of the bottom chord and principal rafter can be seen on several of the trusses, particularly on the east side of the hall and the west end of the southernmost truss (see Plate 8). There are no particular signs of distress or failure of the trusses and no indication of spreading or opening of the joints. Plate 7

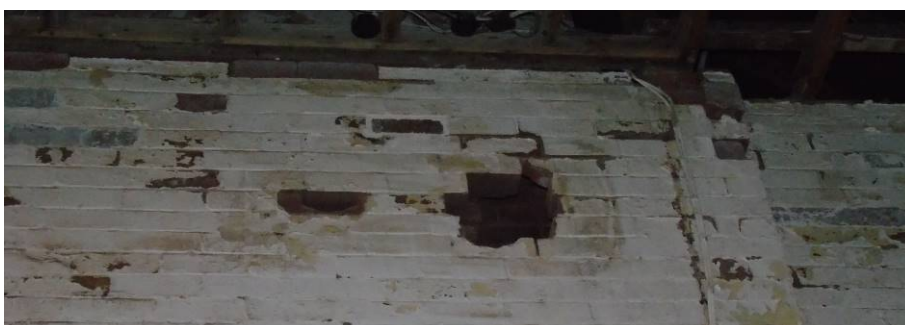
Plate 13

- 2.05 The inside face of the first floor is lined with tongue-and-groove boarding. This boarding appears to have been placed on the north wall of the first floor accommodation but much of it is now missing. This has exposed the brickwork (see Plate 12). The central area of the north wall includes a fireplace and chimney breast and it appears that the chimney may have risen through the apex of the roof. This has now been removed below the roof line and two additional common rafters have been put in place to support the roof covering where the chimney is missing. Throughout the brickwork of this internal wall on the north side of this two storey accommodation, there is extensive erosion of the mortar joints and several areas where bricks have become dislodged or are missing. There are holes on the hall/north side of this wall into the voids in the middle section which could lead into the flue (see Plate 13). This internal wall generally appears to be formed with 9-inch brickwork either side of the central chimney breast. The arch former over the fireplace in the north wall has suffered extensively from corrosion. This may have caused some disturbance to the surrounding brickwork. Behind the bulkheads on the east and west side, the top of the brick walls can be seen. These sections of wall contain alternate courses of stretcher and header indicating that it is at least 9 inches thick. At the eaves, it can be seen that there is a further thickness of brickwork beyond the inner 9-inch, possibly indicating that there is 18 inches of brickwork in total. On the south wall, headers and stretchers can also be seen on the inside face. It is therefore possible that the south wall is also formed in 13½ inch thickness of brickwork.

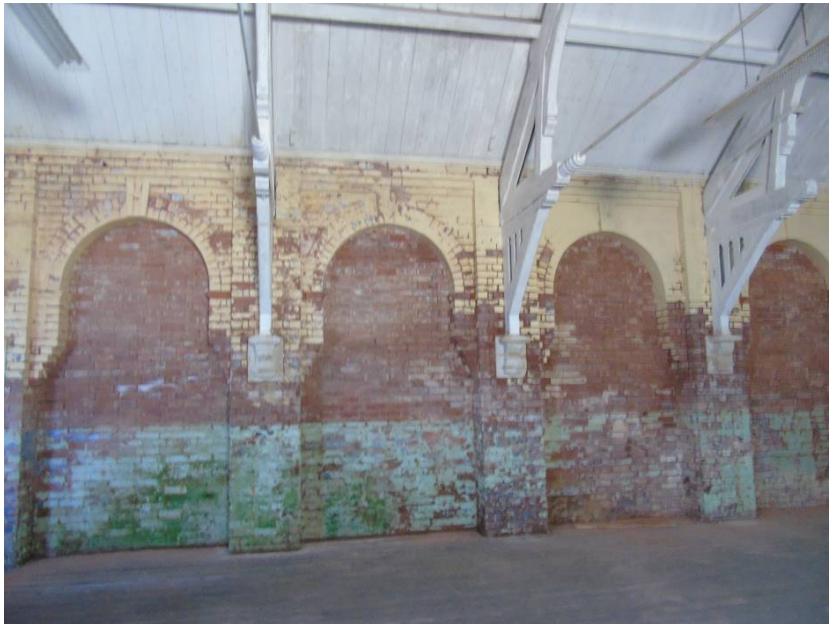
Plate 18

- 2.10 Main hall. Painted brickwork forms the internal surfaces of the walls of the main hall. Much of the paint has peeled away and there is extensive efflorescence on the internal surface, particularly on the inside of the east wall. Some erosion of the mortar joints has also occurred throughout the brickwork, particularly on the east wall and the five northernmost bays of the west wall. The west wall is formed with a series of brick piers which align with and support the trusses with recesses in between with corbeled brick arches above (see Plate 18). In the northern two bays, the erosion of the brickwork and the mortar joints is such that the daylight can be seen through them (see Plate 19). It appears from this that the infill bays between the piers are formed with 4-inch brickwork. However, there are no actual signs of cracking or movement throughout the brick walls.

- 3.03 Extensive erosion of the brickwork and the mortar joints has occurred in various locations within this building. It is likely that spray from seawater containing sea salts has reacted with some of the mortar and caused it to deteriorate. This has led to joints emptying of mortar and there are also several instances of the bricks themselves becoming damaged and eroded. This appears to be particularly so on the internal wall between the two storey section and the main hall. This may be due to the ingress of water through the former chimney stack which has now been removed. However, spray and rain driven against the walls could have allowed them to become saturated throughout the wall thickness, especially once the render had been eroded from the external surface. Where this erosion has occurred, stabilisation of the brickwork may be required which for the most part of may mean the removal of the affected brickwork and its reconstruction. Where the bricks have been damaged or are missing, these will need to be replaced and to some extent, the mortar joints will need to be raked out and refilled with new mortar.

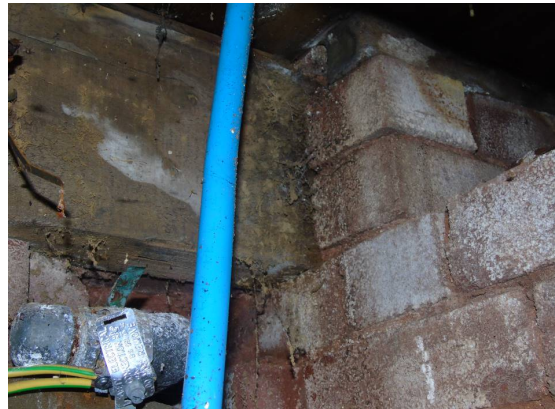
- 2.12 Hall floor. The floorboarding of the hall is generally intact with only a couple boards having swelled and bowed up at the southern end of the hall. Within the basement below, it can be seen that the floor joists span from east to west and are 200 x 75 mm in size at 400 mm centres. The floor joists are generally supported on a ledge in the brickwork on the west wall and built into the face of the east wall. The maximum span of the joists is 3.25 m. Some decay has occurred in the western end of the southernmost joist where it is built into the brickwork (see Plate 20). The joists are provided with intermediate support across the width of the building by two lines of steel beams which are 10-inch x 5 inch I-section and span up to 6 m between supports. At the southern end of the building, the two steel beams are set closer together and provide direct support for the 9-inch brick walls above. Both of these beams have suffered from extensive corrosion, particularly towards their southern end (see Plate 21). The southern joist spanning eastward from the eastern beam has suffered extensively from decay where it sits on the top of a brickwork ledge. Two steel beams can be seen which span over this eastern section of the basement and probably coincide with the internal wall dividing the hall from the two-storey part. Extensive corrosion has occurred at the eastern end of these beams (see Plate 22). Corrosion has also occurred where the steel floor beams are built into the north wall (see Plate 23).

- 3.04 The floor construction is generally sound with adequate sized floor joists and steel beams. However, the corroded sections of steel beam at the southern end of the building have reached a point where they are beyond repair and will therefore need to be replaced. This will require the temporary support of the floor joists and the internal brickwork walls on either side of the entrance lobby while the beams are replaced. Other sections where corrosion has occurred, such as the northern bearings of the beams and the eastern bearing of the beam supporting the wall between the two storey section and the hall, will need to have the existing corrosion cleared from the surface and removed so that the remaining section can be checked for its adequacy and protected from further corrosion.

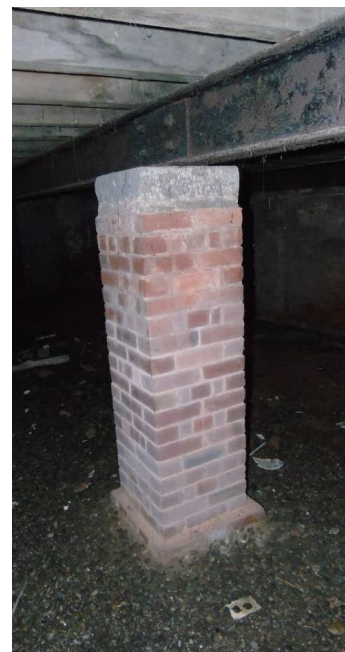
Plate 25

- 2.13 Basement. In the south wall of the basement, there are openings which have been filled with blockwork. The west wall is formed with a series of brick arches which are sat on in 18 x 23-inch piers (see Plate 24). The steel beams are supported by two 18-inch square brick piers on each length which are capped with granite padstones (see Plate 25). Adjacent to the eastern of the steel beams, a line of brickwork wall has been formed. To the west of this brickwork wall, the floor is gravel. To the east, a concrete floor has been laid. To the east of this wall, a concrete slab has been laid over the gravel. Arches can also be seen in the east wall but these have all been infilled with brickwork so that it is flush with the inner face of the piers and arches. An area at the southern end of the eastern part of the basement could not be accessed as it appears to be boarded off. There are further brickwork walls at the northern end of the basement. It is not clear whether these are original or have been added. The stairs giving access to the basement have walls formed with a timber frame on the north, west and east sides. This includes more substantial timber posts. Decay has occurred at the bottom of these posts (see Plate 26).

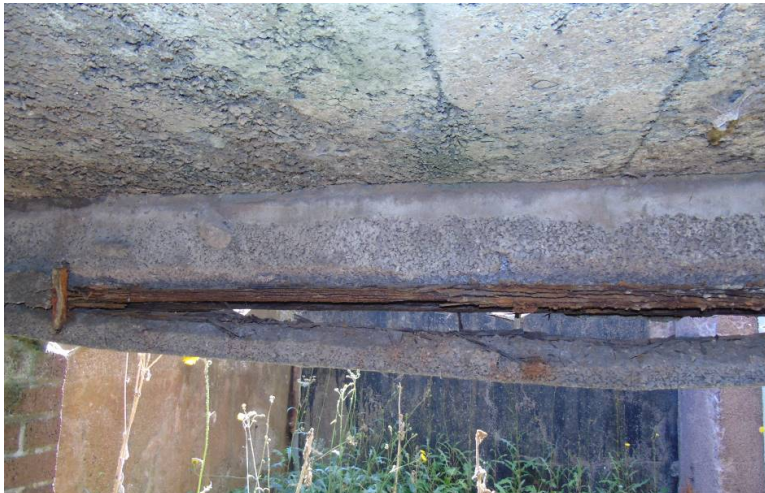
Plate 32

- 2.16 South elevation. A reinforced concrete deck bridges between the retaining wall to the south of the building and the entrance door. Extensive erosion has occurred on the underside of this deck with concrete having spalled away from the underside (see Plate 31). Concrete has peeled away from the edge beam on the west side of the deck to reveal corroding reinforcement (see Plate 32). Corroded steel and missing concrete can also be seen on the underside of the edge beam on the east side of the deck (see Plate 33). The brick piers and walling either side of the bridging deck are formed in much later brickwork.

- 3.06 It is evident that the salt-laden water has also caused corrosion in the steel reinforcement for some of the reinforced concrete elements of the building including

the bridge deck in front of the main entrance and the beams supporting the toilet block. The extent of the corrosion in the beams below the toilet block could not be identified as they were still concealed within the concrete. However, it is likely that this reinforcement would need to be exposed and the corroded metal removed before replacing the cracked concrete. With regard to the bridge deck, the corrosion of the edge beams is such that the beams as a whole will need to be replaced. As the condition of the reinforcement within the deck itself is unknown, it may be prudent to assume that the deck as a whole will require replacement. In view of its location, the replacement should be formed using stainless steel reinforcement.

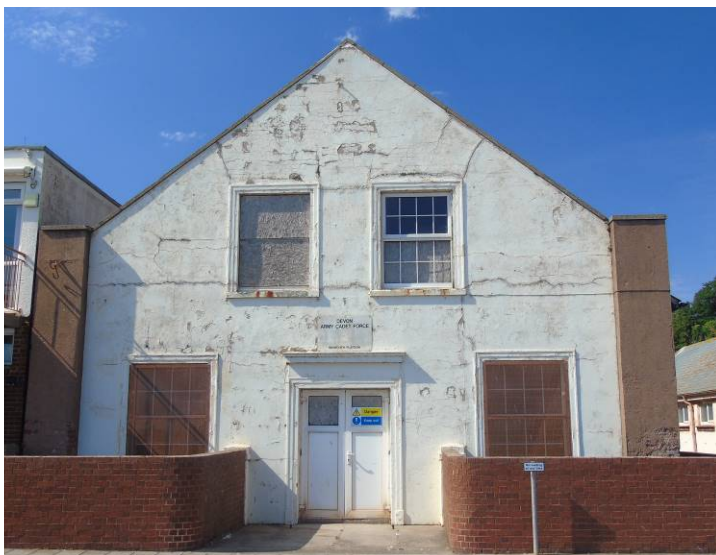
Plate 34

- 2.17 The external face of the south wall is coated with a cement-based render which has been painted. Much the paint is peeling away and there are several cracks in the surface of the render. Numerous cracks can be seen throughout the height of the wall and the top of the gable peak appears to be leaning southwards. In particular, there is a line of horizontal cracking just above the level of the sills of the first floor windows (see Plate 34). Some erosion of the capping stones can also be seen at the top of the south elevation. Reinforcing rods have become exposed on the outer surface (see Plate 35).

- 3.02 There are no signs of settlement or substantial movement in the wall construction. There is a slight lean in the top of the south gable peak. The cause of this could not be identified. However, it may relate to steel components that are corroding and lifting the inside edge of the wall. The wall construction generally appears to be in solid brickwork of varying thickness. For most of the north and south gables, the brickwork appears to be one and a half bricks thick, giving an overall thickness of approximately 13½ inches/375 mm. There is the possibility that some areas been formed with cavity work but they have not been positively identified. There is the possibility that some wall ties exist in the south gable and that these or some other steel component is suffering from corrosion and causing the horizontal cracking which can be seen in the external render. Some areas, notably the infill sections between the piers and arches in the west wall, are formed with 4-inch brickwork.

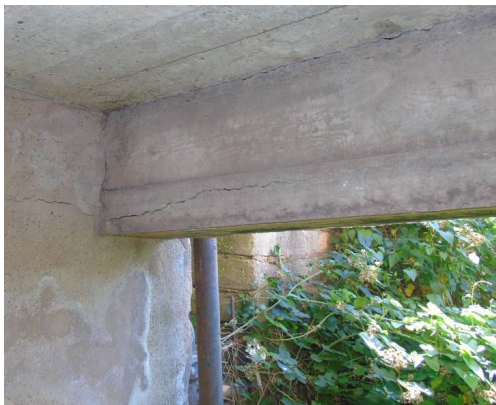
Plate 36

- 2.19 Below the toilet block attached to the north elevation, it can be seen that it is formed with a cast in situ concrete slab with downstand beams. The beams are supported on the north east and north west corners by rendered columns which may conceal reinforced concrete. Some cracking can be seen in the face of the western downstand beam at its southern end (see Plate 36) and towards the north end (see Plate 37). There is also cracking on the face of the southern end of the eastern beam (see Plate 38). Above the reinforced concrete beams, the outer faces of the walls are rendered. Horizontal cracking can be seen either side of the window opening in the east wall (see Plate 39). Cracking can also be seen in the render at window head height in the north wall and there is an area of cracking around and below two steel tubes which pass out through the wall at the centre (see Plate 40). Horizontal cracking can also be seen in the render in line with the head of the window in the west wall (see Plate 41).

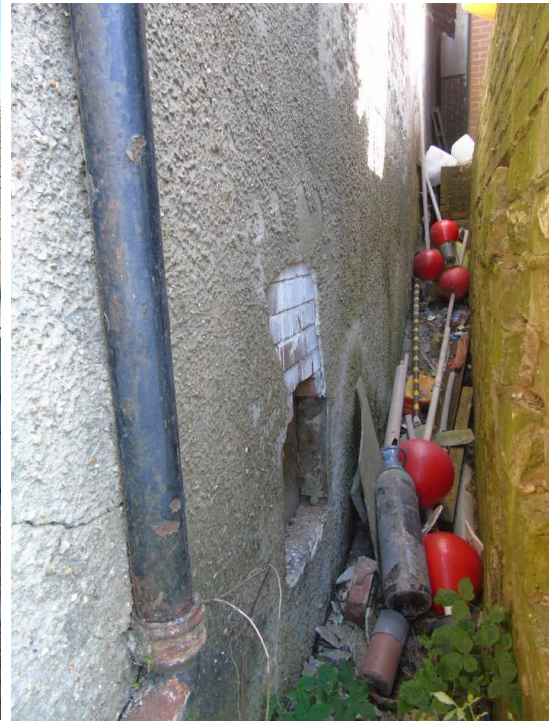
Plate 43

- 2.20 West wall. The southern part of the wall is obscured by the adjoining building with a valley gutter between the two buildings (see Plate 42). A small gap exists at the northern end which is largely inaccessible. Debris fills the gap between the Drill Hall and the retaining wall forming the area to the west (see Plate 43). However, it can be seen from this side, that the infill panels of brickwork are formed with just 4 inches thickness. The gutter is mostly missing from the eaves and there appears to be some decay of the rafter ends towards the southern end of this area. (see Plate 44)
